**Flood Control Project Maintenance
Levee Inspections**
LMA District Cover Sheet
Spring 2010 Levee Inspection Results

Sacramento Maintenance Yard Sacramento Bypass

Levee Inspection Report By Mile - Spring 2010

Waterway						Bank	Unit Miles	Inspection Start/End	Inspector	
Unit No. 01 Sacramento Bypass or North Levee						Right	1.73	03/22/2010 03/22/2010	John Williamson

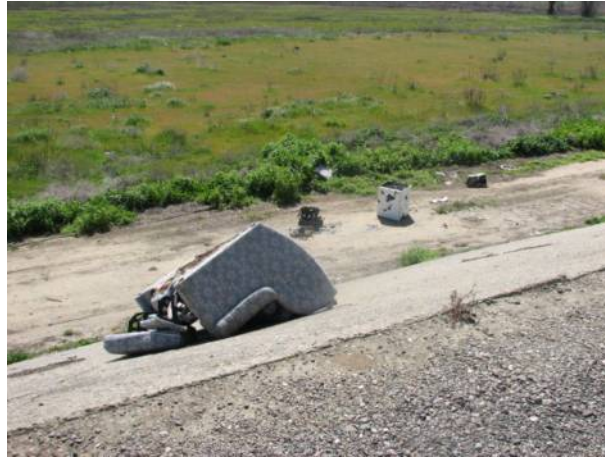
johngw_s_20100323_045.jpg

Levee Mile Report Line	2
Start Levee Mile	0.34
End Levee Mile	0.34
Location	Water Side
Category	Earthen Levee
Item	Encroachments

Debris dumped in the Bypass
